## WEST BOUNDARY WALL REPAIR, ARLINGTON NATIONAL CEMETERY, ARLINGTON COUNTY, VIRGINIA

John H. Haynes, RPA  
U.S. Army Corps of Engineers, Norfolk District  
June 2015

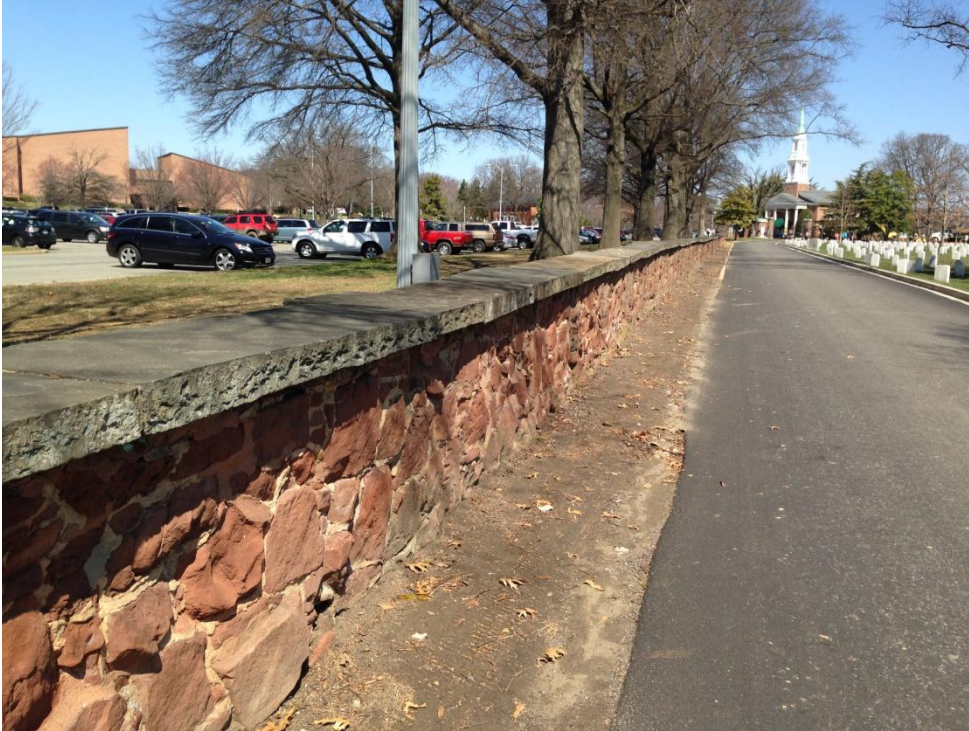
Photo 1 - (Figure 2) A view north toward the Old Post Chapel along McPherson Drive, showing earth banked up on the cemetery side.

Figure 2 - Photo 1

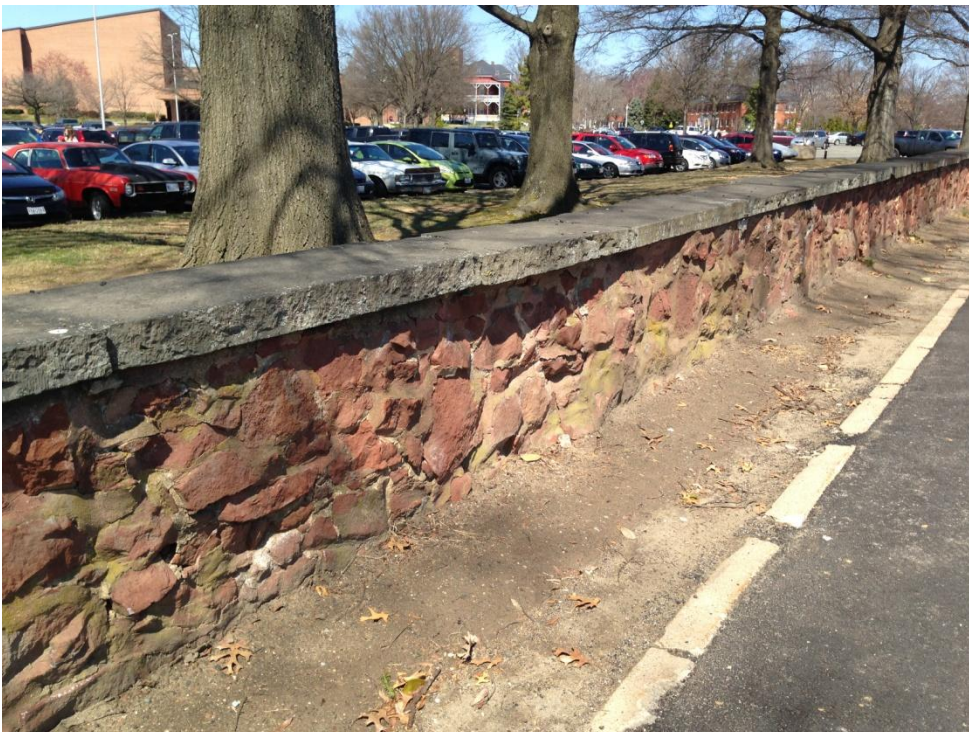
Photo 2 - (Figure 3) Another view north along McPherson Drive showing 1-1.5 feet more soil on the JBM-HH side of the wall.

Figure 3 Photo 2

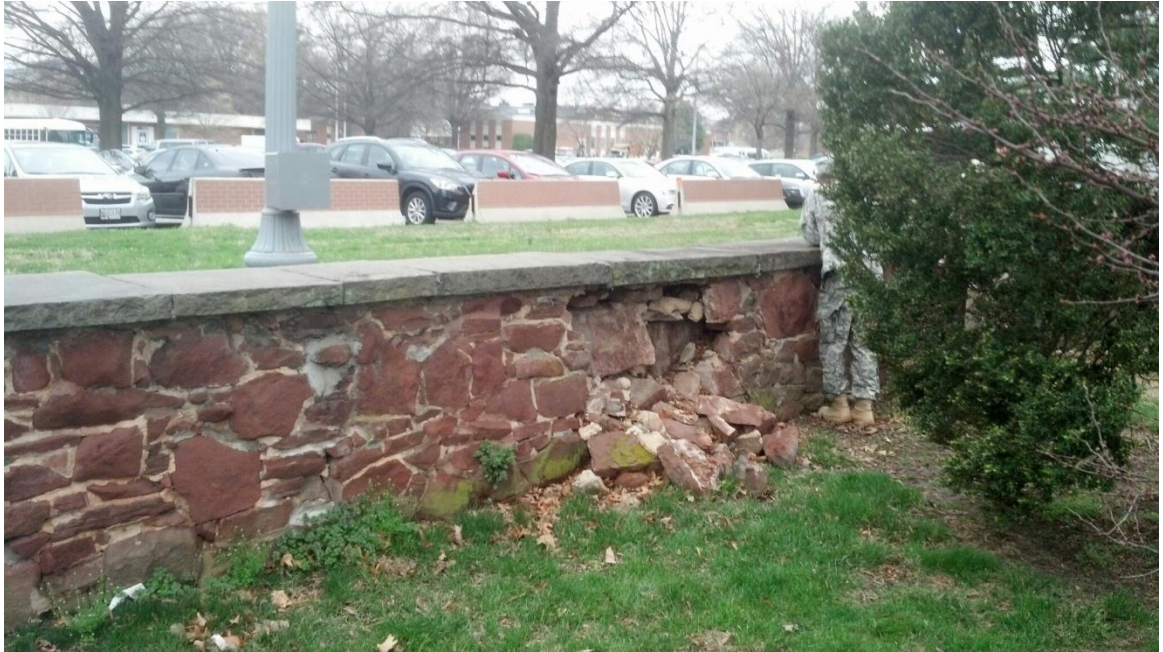
Photo 3 - (Figure 4) A collapsed section of wall just south of McPherson Drive. The lamp post base on the JBM-HH side relative to the ground level on the ANC side illustrates soil build up.

Figure 4 Photo 3 A Collapsed Section of Wall

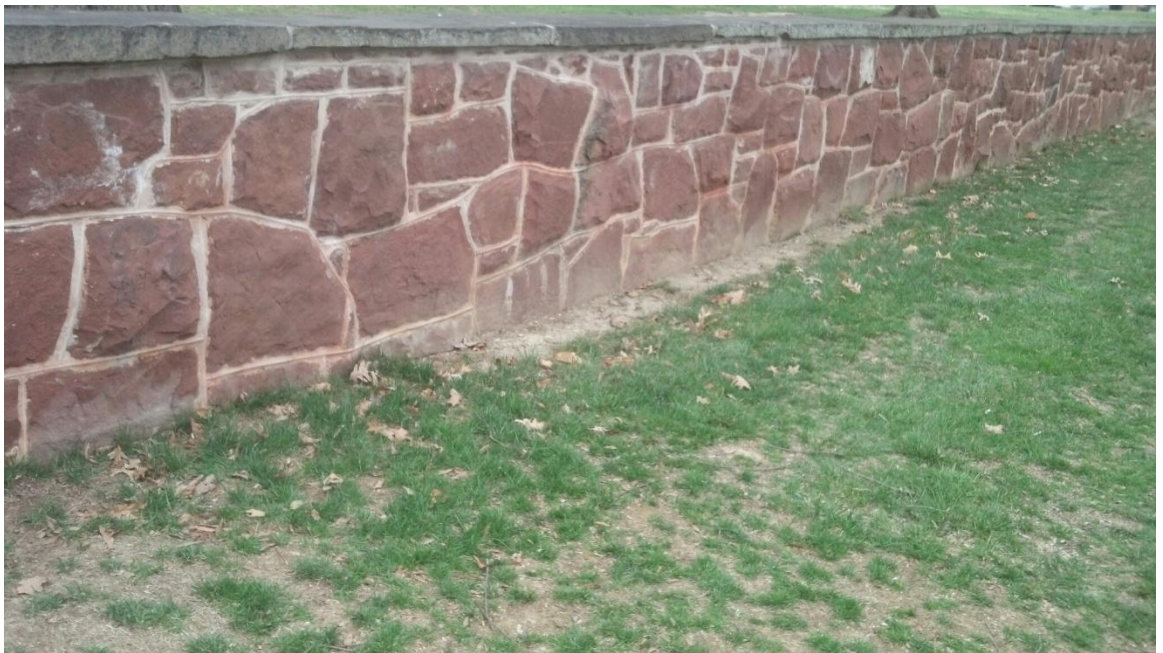
Photo 4 - (Figure 5) A 90 foot section of wall reconstructed in 2009 using the same design proposed by this project.

Figure 5 Photo 4, section of wall reconstructed in 2009

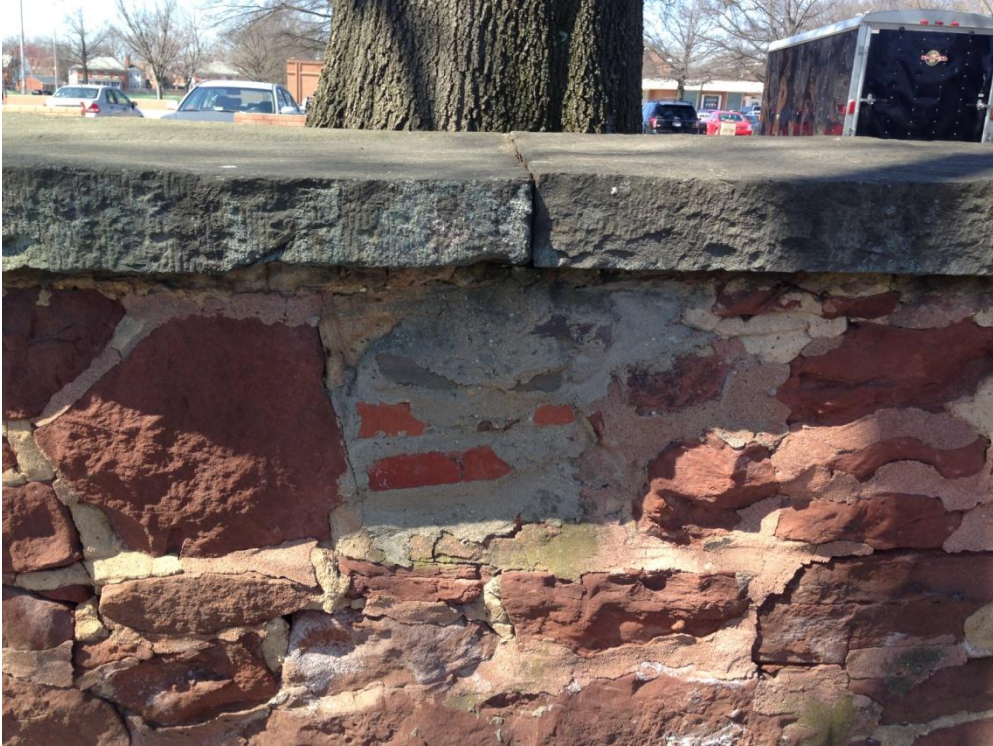
Photo 5 - (Figure 6) An old and inappropriate repair to the red sandstone wall, using mismatched mortar and even brick.

Figure 6 Photo 5, typical of inappropriate repairs made to the walls in the past

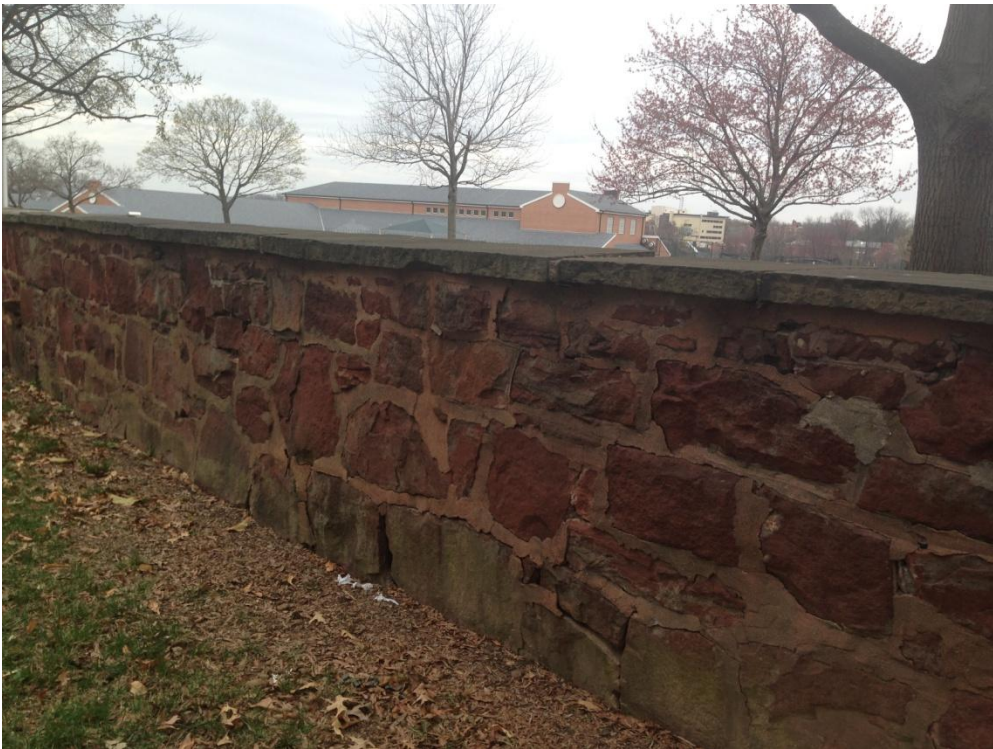
Photo 6 - (Figure 7) A typical section of the segment of the red sandstone wall relocated ca. 1897.

Figure 7 Photo 6, a typical section of the relocated sandstone wall

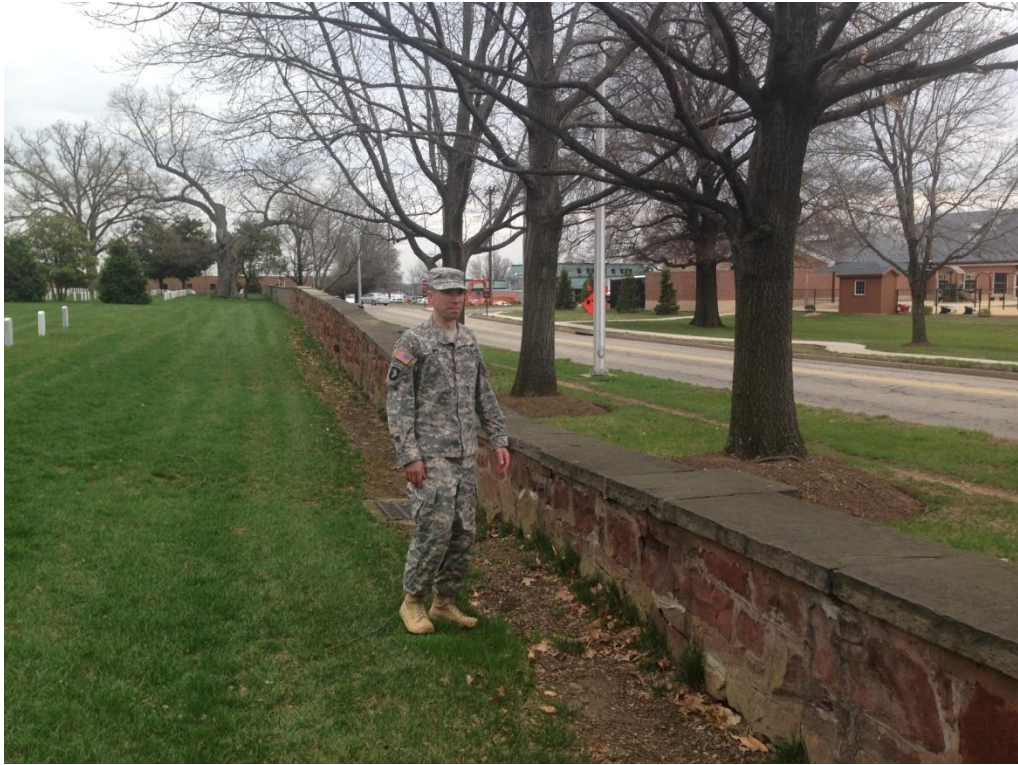
Photo 7 - (Figure 8) Although it is contemporaneous with the segment shown in Photo 6, and a short distance away, the wall is much lower here. This is probably due to soil accumulation on both sides of the wall.

Figure 8 - Photo 7, a “low” section of the wall, where fill has half buried it

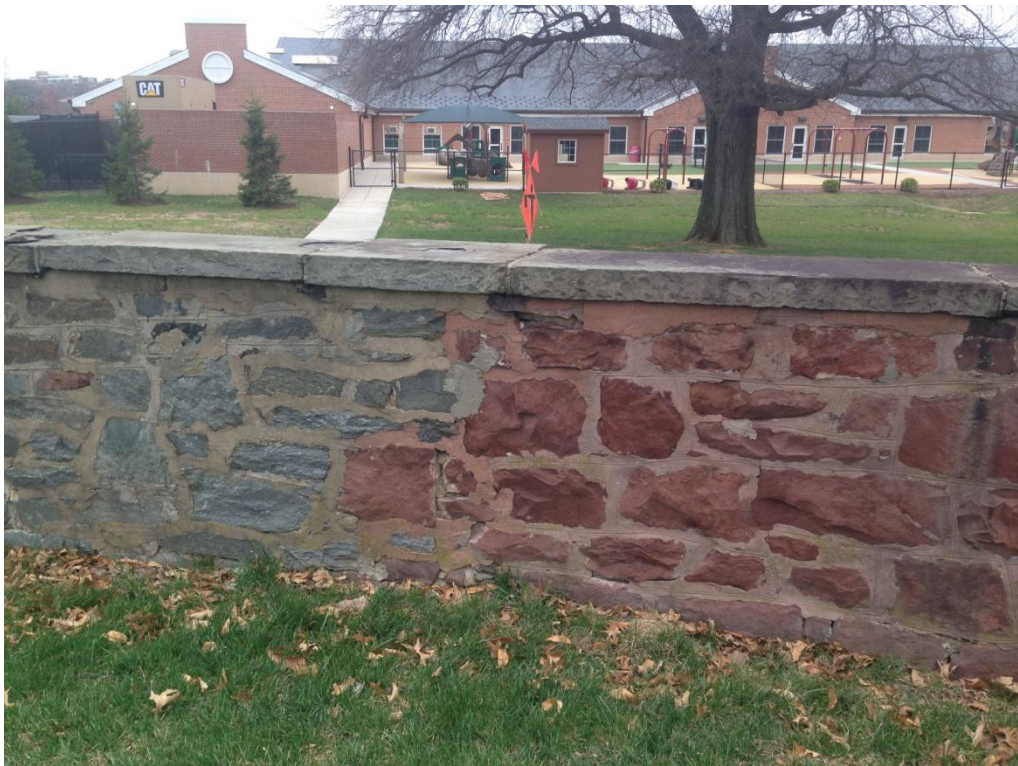
Photo 8 - (Figure 9) Transition from the relocated red sandstone wall to the blue-grey stone wall.

Figure 9 Photo 8, end of red sandstone segment, beginning of blue-grey stone segment

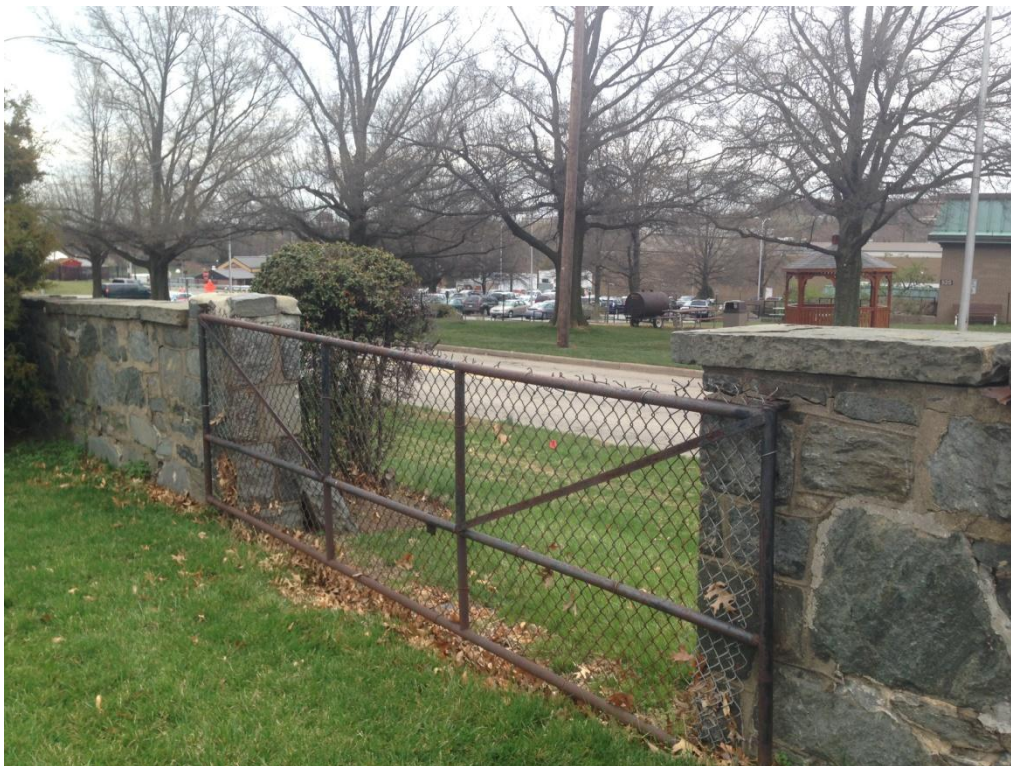
Photo 9 - (Figure 10) The "Rusted Gate," where a section of chain link fencing was expediently mortared into joints in the stone wall some decades ago.

Figure 10 - Photo 9, the "Rusted Gate"

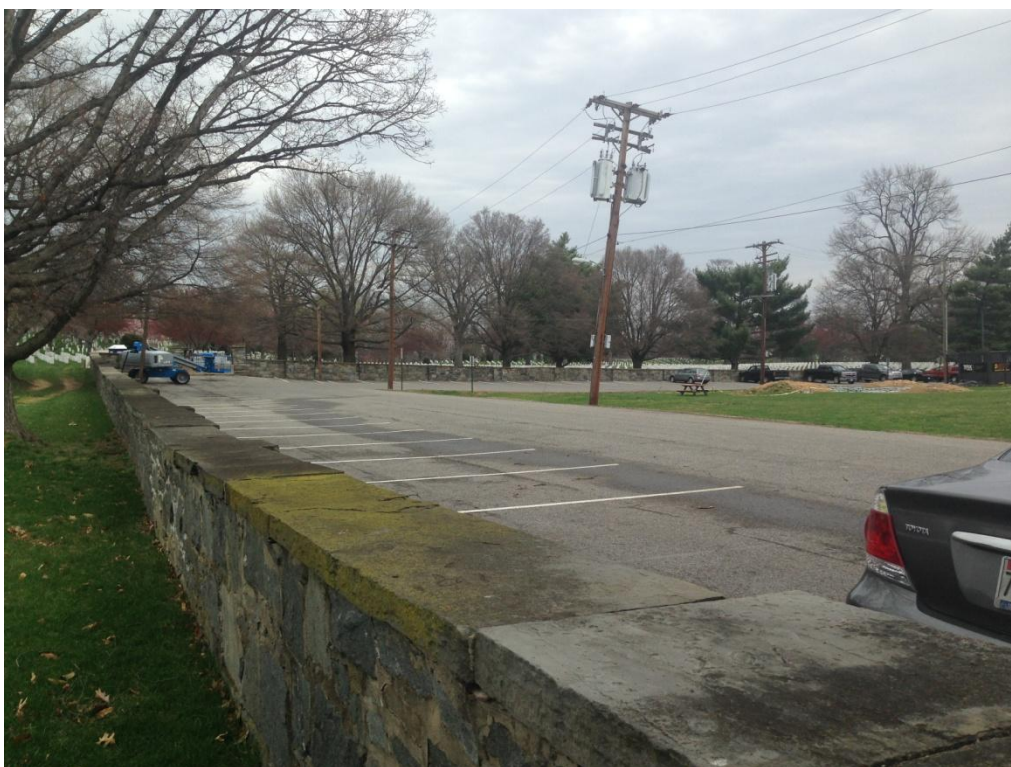
Photo 10 - (Figure 11) A section of the blue-grey stone wall along Hobson Drive. The wall is low here, probably represents soil accumulation on both sides.

Figure 11– Photo 10, Section of the blue-grey stone wall along Hobson Drive, fill and pavement rise to 1.5 feet of the top of the wall on the JBM-HH side.

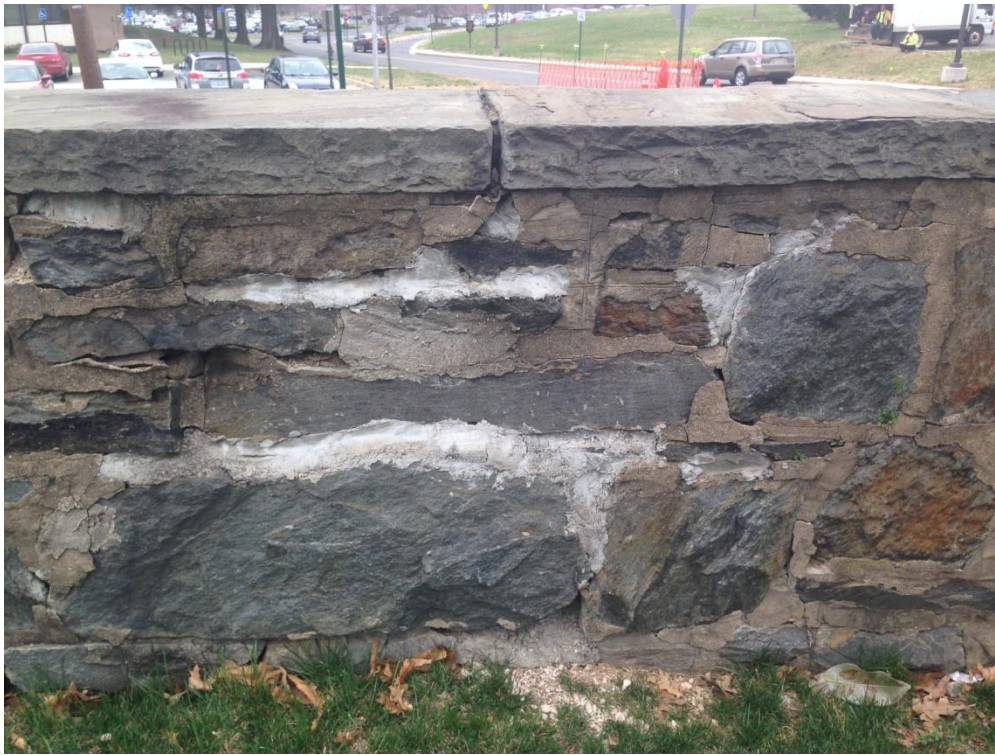
Photo 11 - (Figure 12) An old and inappropriate repair to the blue-grey stone wall using mismatched mortar hastily applied.

Figure 12 - Photo 11, mismatched mortar repair and water damage on the blue-grey stone wall

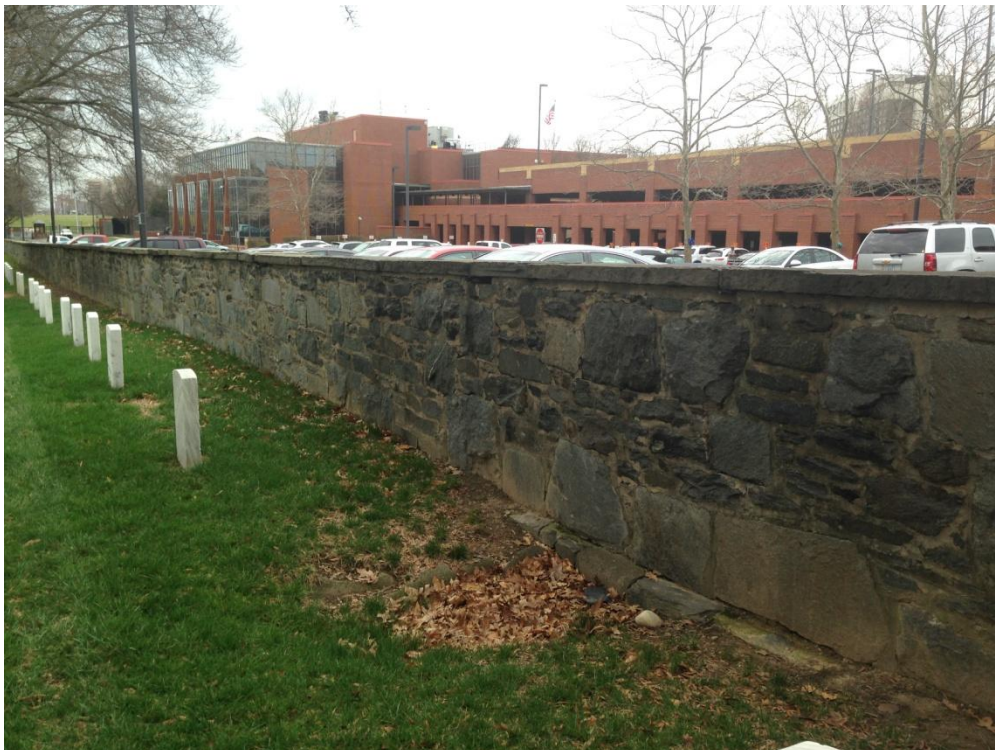
Photo 12 - (Figure 13) A section of wall along Hobson Drive behind Henderson Hall. Compare this with the height of the wall in Photo 13, which is just to the southeast of it.

Figure 13- Photo 12, section of wall along Hobson Drive behind Henderson Hall

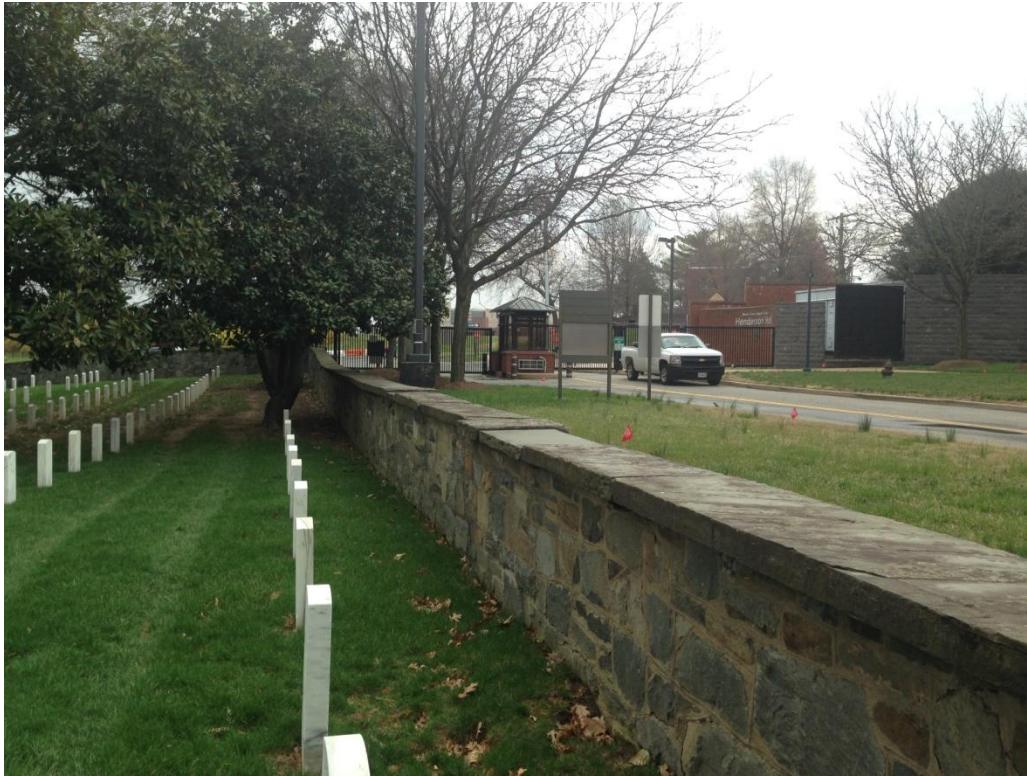
Photo 13 - (Figure 14) Facing southeast along Hobson Drive toward JBM-HH Gate 3. Higher ground level on the JBM-HH side is readily apparent, and soil has apparently accumulated on both sides with the ground level high relative to the wall on the ANC side as well.

Figure 14 - Photo 13, section of wall along Hobson Drive at JBM-HH Gate 3. Notice soil surface higher on the JBM-HH side, and low profile of the wall on the cemetery side as well indicating substantial fill accumulation.
